PROJECT DOSSIER

New Chirajara Bridge Project, Colombia

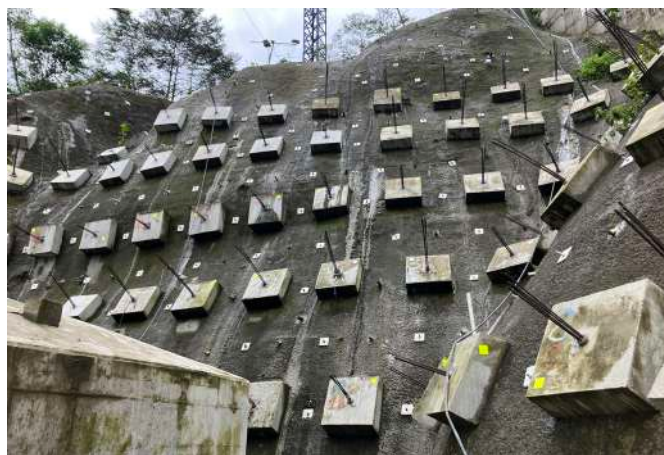
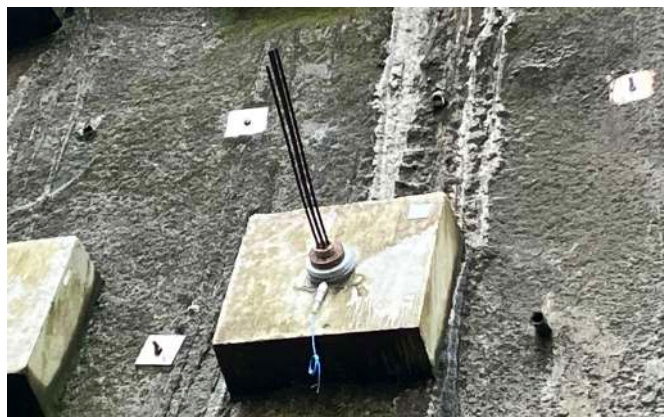
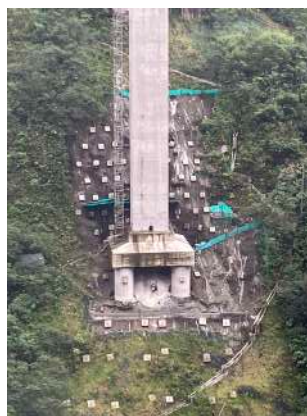
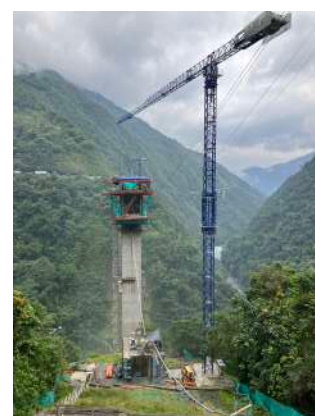
Load cells being used for slope stability

- **Load Cells**
Load cells were installed at the anchor heads of rock bolts, they are used to determine the load these bolts bear to contain and prevent landslides in the pile foundation areas
- **Tiltmeters**
Tilt meters were installed to monitor variations in the tilt of piles and other structures in the project.
- **Piezometer**
VW Piezometer: installed to monitor the variations in groundwater level and its effect on the infrastructure and the natural slopes.
- **RF nodes / gateway**
RF dataloggers (nodes) with gateway was deployed to automate and remotely transmit data from the project area to the data management system.
